Pilot 4

Pre-demolition activities

Nortura building – Old slaughterhouse in Sortland is built in 1960, and remodeled in 1982/1998, with surface area of 7300 m²

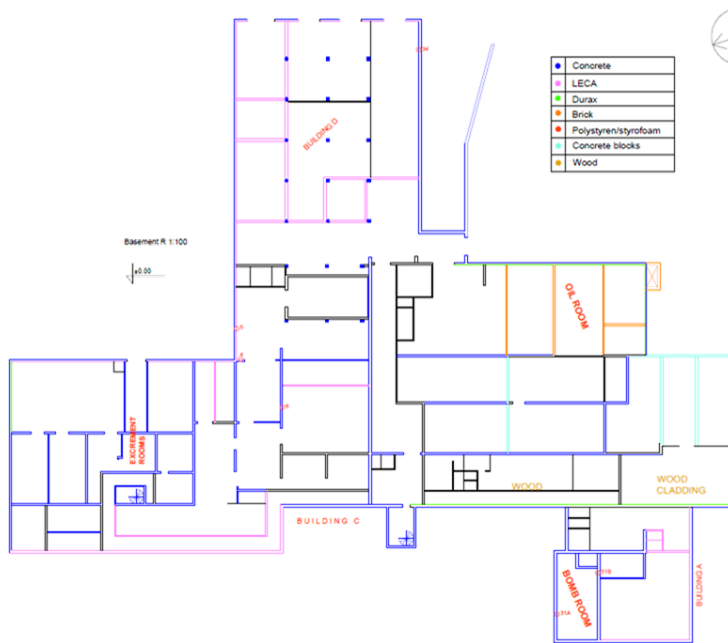
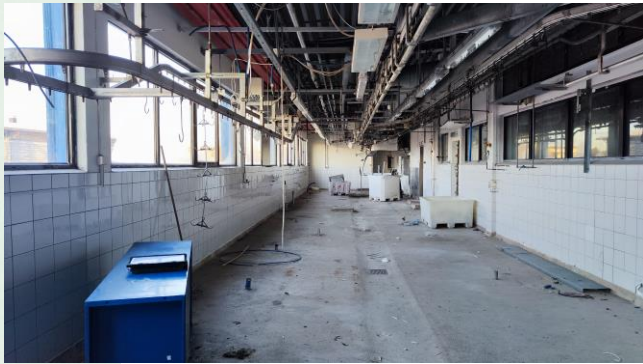
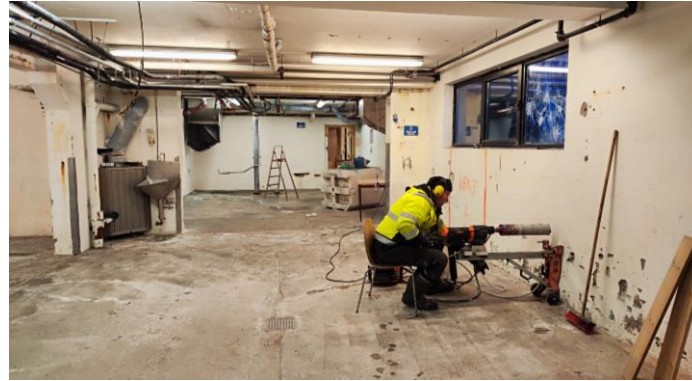
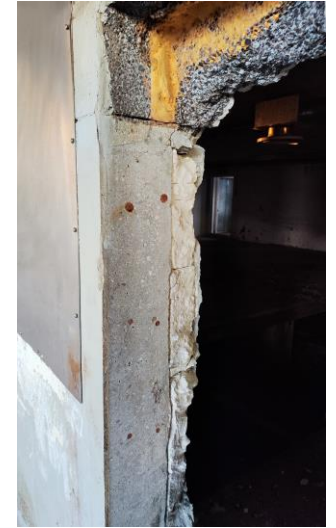
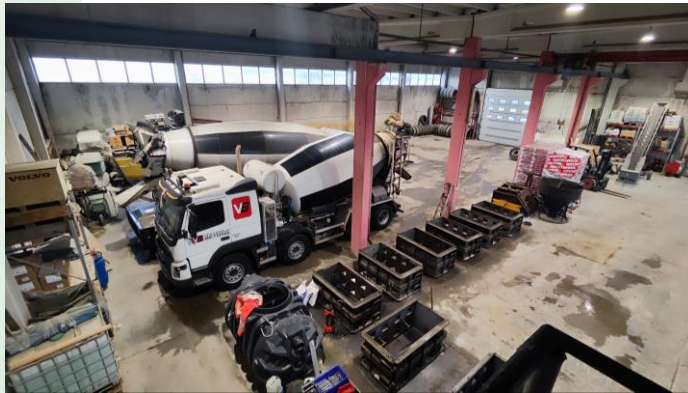
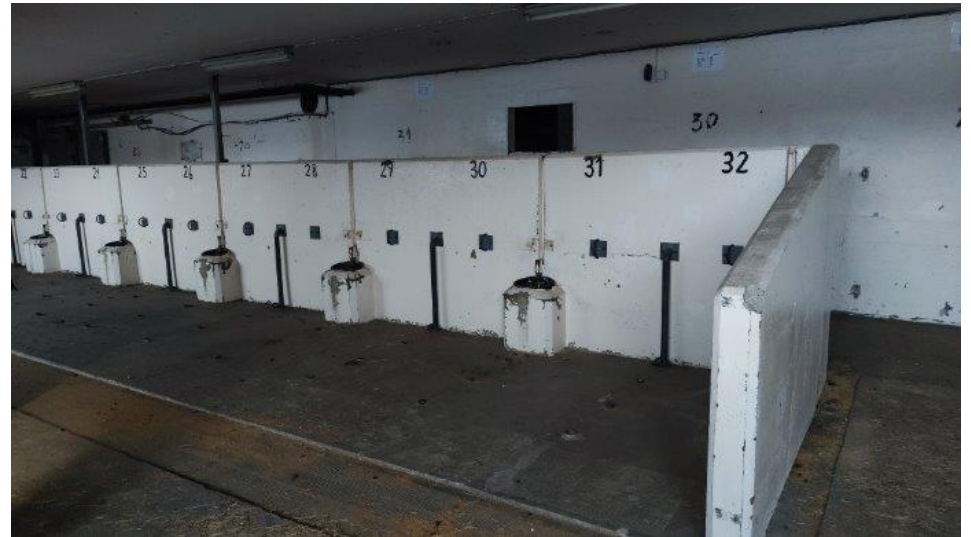
- Collection of existing documentation, visual inspection, and environmental mapping
- Geometry and material mapping of the Nortura building

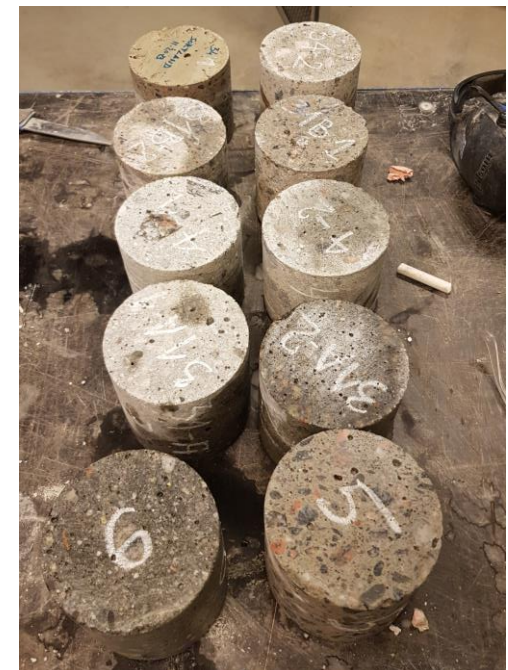
- 5 concrete cores were extracted from different areas of the structure
- Compressive strength test according to EN 12504-1:2019
- Average strength from Schmidt hammer = 47 MPa (st.dev. 4.9 MPa)

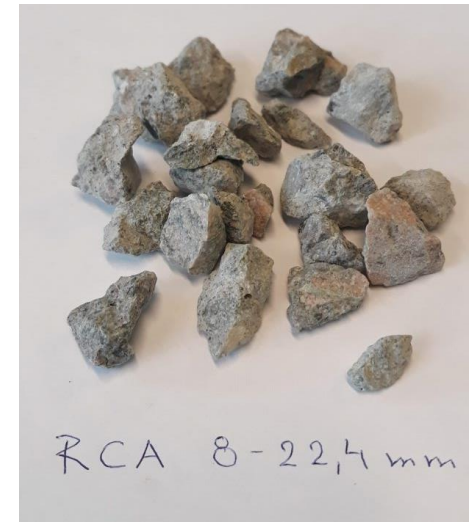
- Cores were processed in a jaw crusher into RCA and tested for density, water absorption, particle size distribution by sieving method, and shape index according to NS-EN 12620.

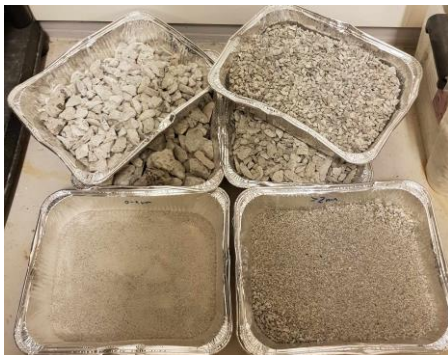
Sieve size [mm]	Saturated surface dried particle density [g/cm ³]	Water absorption [%]	Shape index [-]	
0/4	2.202	10.59	-	-
4/8	2.045	6.79	52.17	SI40
8/16	2.154	7.29	47.32	SI55
16/22	2.10	6.71	29.83	SI55
